**ADDU CORAL MINING / BEACH EROSION
STUDY**

30 JANUARY - 1 FEBRUARY 1990

Prepared By
MARINE RESEARCH SECTION
MINISTRY OF FISHERIES AND AGRICULTURE
REPUBLIC OF MALDIVES

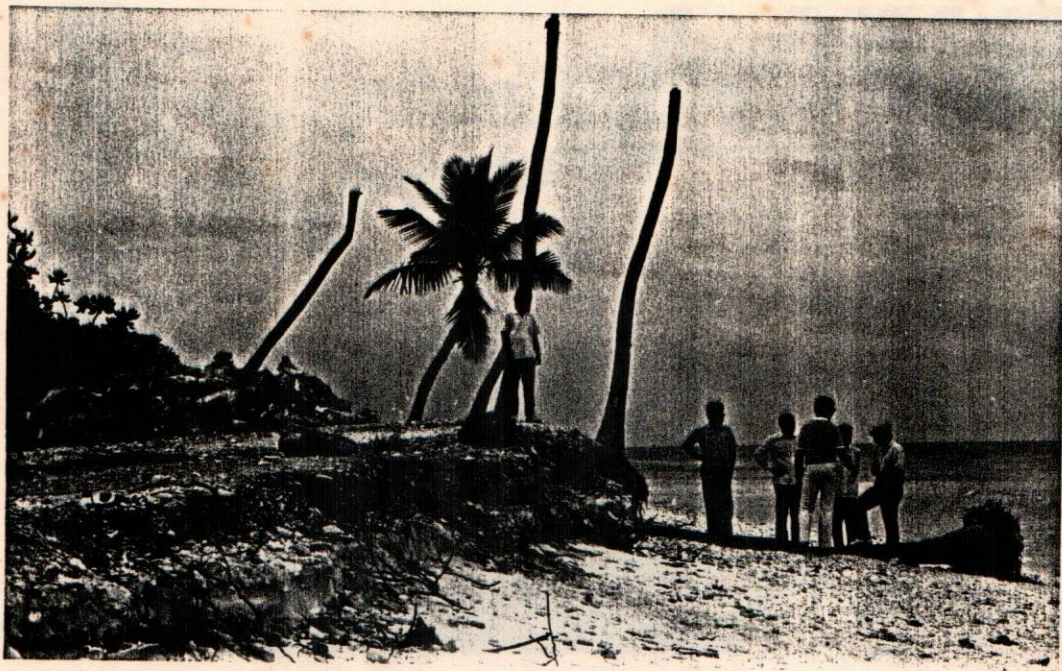
Only one site near Hithadhoo Corte (fig. 1, plate 1) shows any link between coral mining and beach erosion. Dead coral in the intertidal and immediate sublittoral has been removed resulting in increased wave energy reaching the shore. The problem is not significant and the area is not inhabited. Further deterioration will occur but will be reduced (unless there is a severe storm) if further mining is stopped in this region.

Plate 1 - The only beach erosion that could be due to coral mining was observed at Hithadhoo Corte (fig. 1).

- 5 Artificial restoration of the reef areas that have already been mined is not practical.
- 6 The eroded beach at Hithadhoo Corte should be left to stabilise to the new wave regime created by mining.

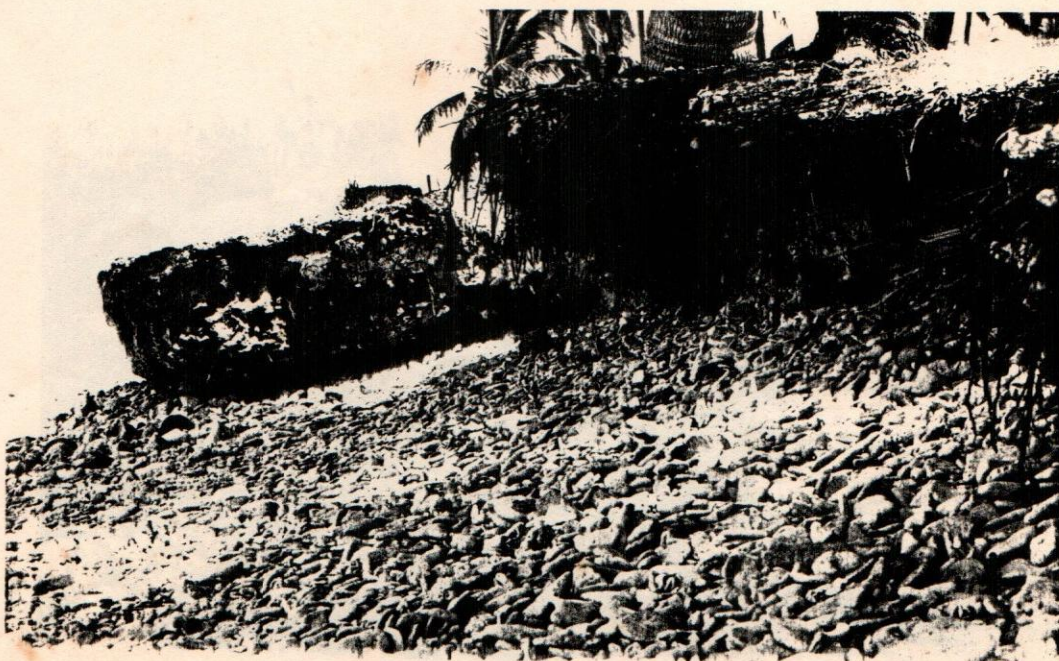
Minor beach erosion on the north east shore of Meedhoo (fig. 6, plate 2) is due to a number of factors.

- 1 Aggregate is directly mined from the beach.
- 2 Coral rubble has been removed from the reef rampart resulting in increased wave energy reaching the shore.
- 3 Severe storms have caused short term erosion.

Plate 2 - Beach erosion at the RAF gun emplacement on Meedhoo (fig. 6) is due to several factors including aggregate mining, coral rubble removal from the reef rampart, and storms.

The rate of erosion will be reduced if aggregate mining and rubble collection are banned and the reef remains healthy.

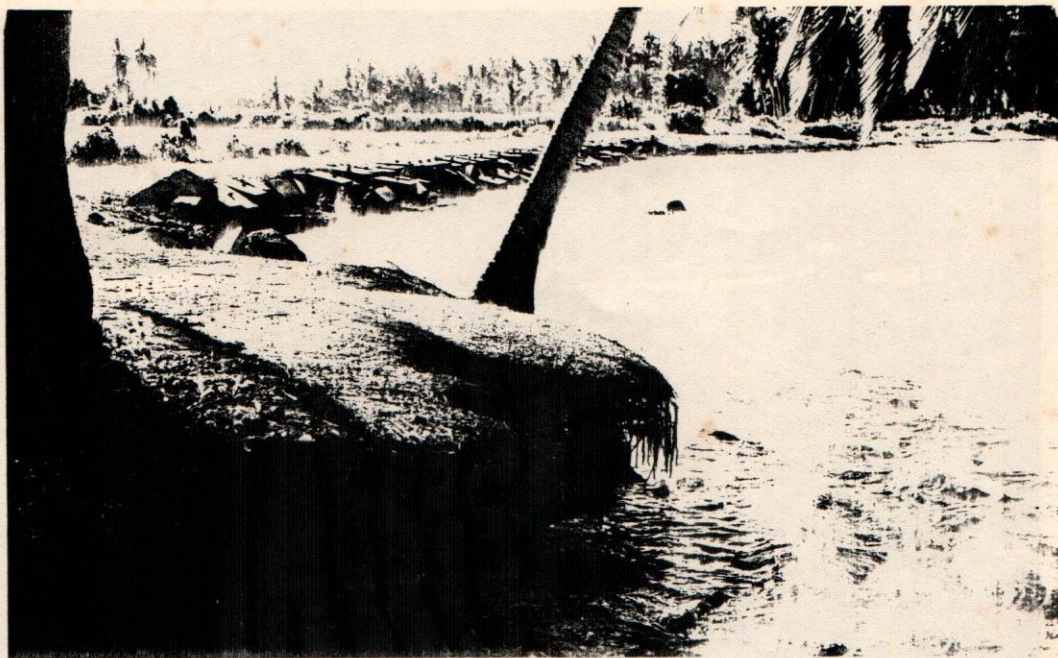
The lagoonside shore at the Fedu end of the Fedu-Maradu causeway continues to erode back (plate 3) and continuing efforts are being made to protect the shoreline with coral.

Plate 3 - Solid causeway construction has led to severe beach erosion at the Fedu end of the Fedu-Maradu causeway (fig. 8).

- iv. It may prove beneficial and prograde (advance) the beach where it is eroding on the lagoonside of the Fedu end of the Fedu-Maradu causeway by positioning a detached breakwater offshore.

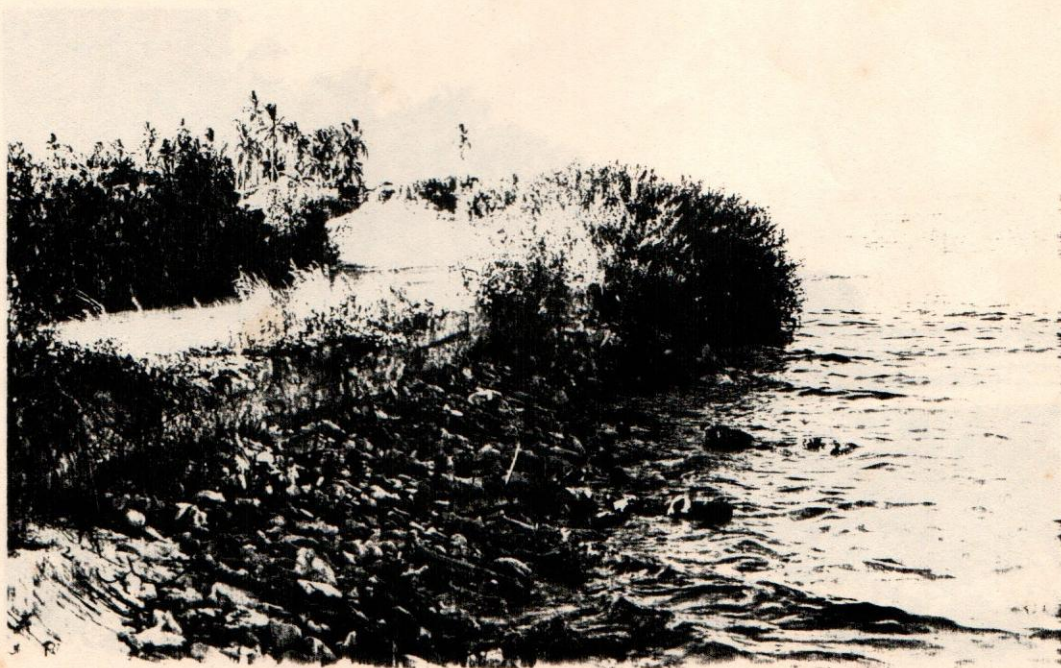
Some (? seasonal) erosion has taken place on the lagoonside of the causeway and particularly at the Maradu end (plate 4). The causeway in this region is in danger of subsidence and needs to be shored-up.

Plate 4 - The Maradu end of the Maradu-Hankada causeway is in serious danger of undercutting and collapse and the bank should be shored up.

In the meantime it should be noted that the Maradu end of the Fedu-Maradu causeway is in serious danger of undercutting and collapse (plate 4) and the bank should be shored up.

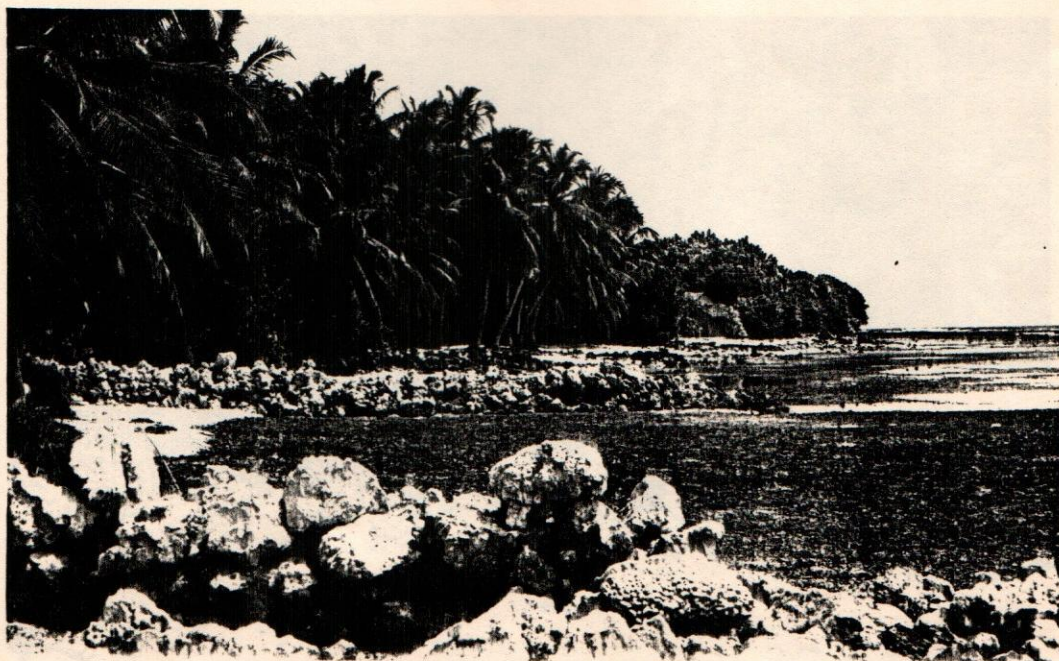
Plate 6 - Efforts to limit beach erosion using groynes in the widening channel between Hulhudhoo and Herethere have proved largely ineffectual (fig. 6-B). Complete blockage of the channel is being considered.

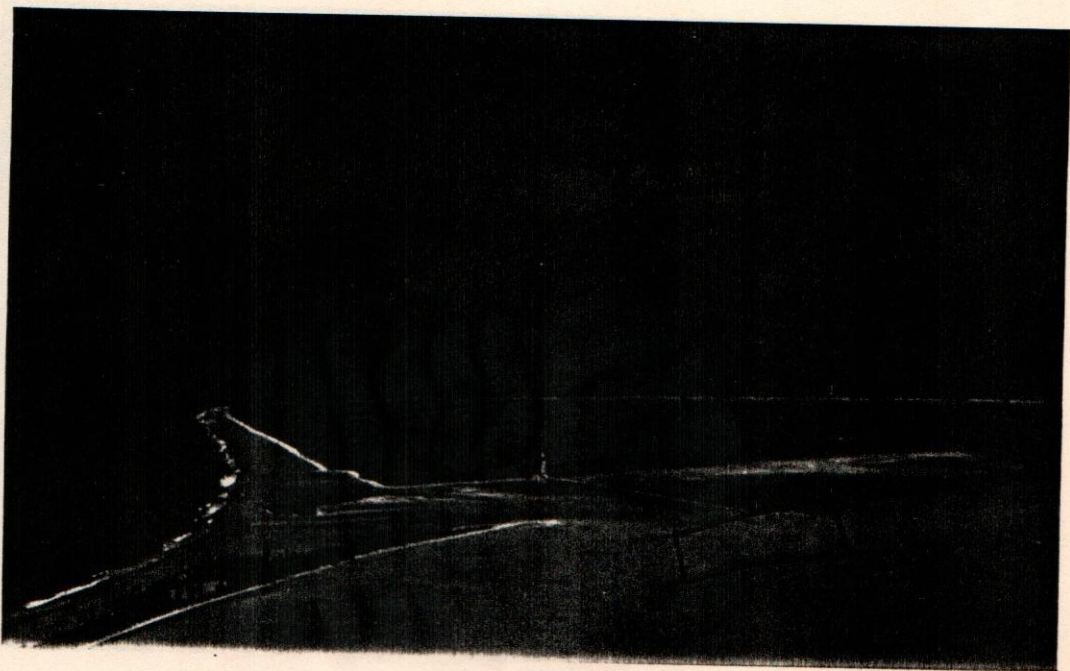
Plate 7 - Current and proposed sand mining area (from air) at 'Medhafushi' off Meedhoo jetty.

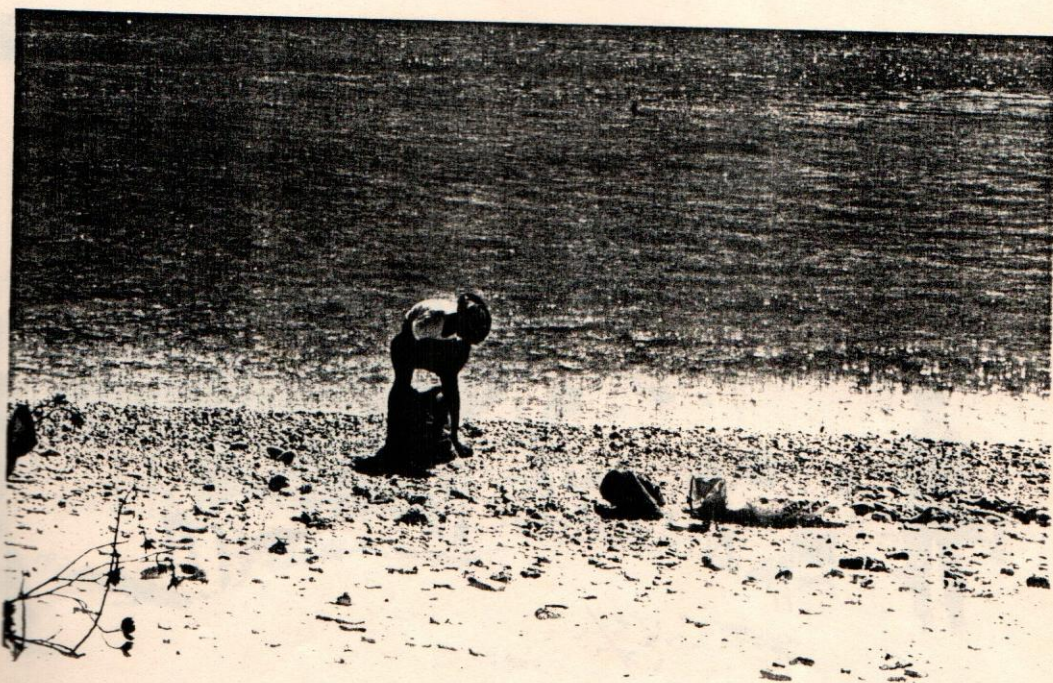
Plate 8 - Sand and aggregate collection off beaches (here at Hithadhoo Corte) is wide spread and directly leads to beach erosion. It is recommended that these activities are prohibited on beaches.

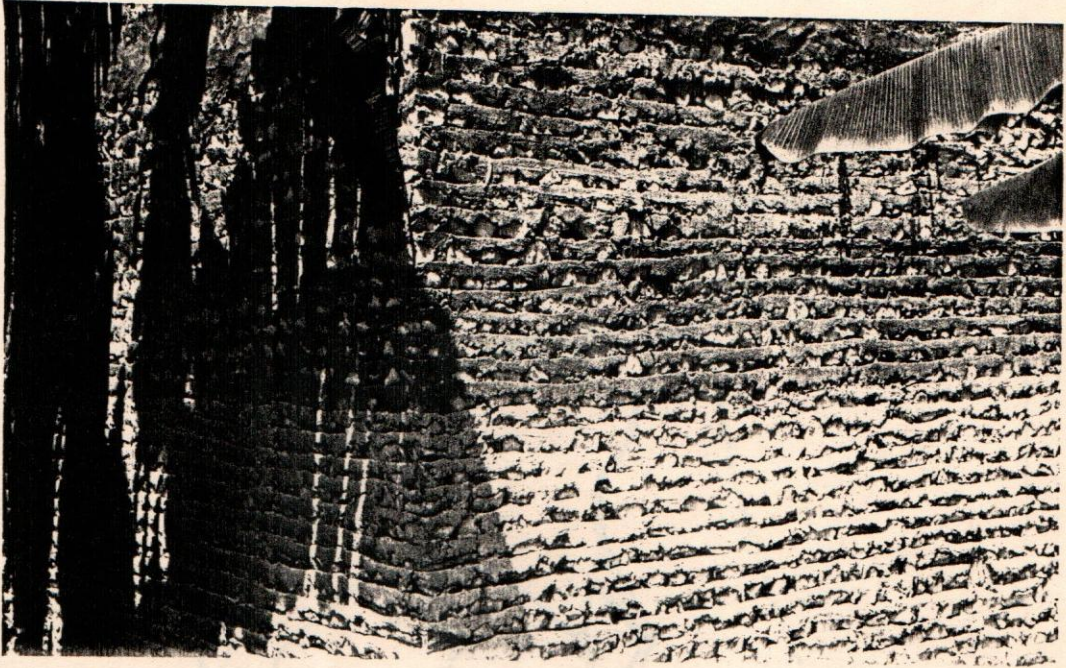
Plate 9 - Construction using coral is still widespread and popular. However, the cost of using this material can be beach erosion and dead reefs that cannot grow.

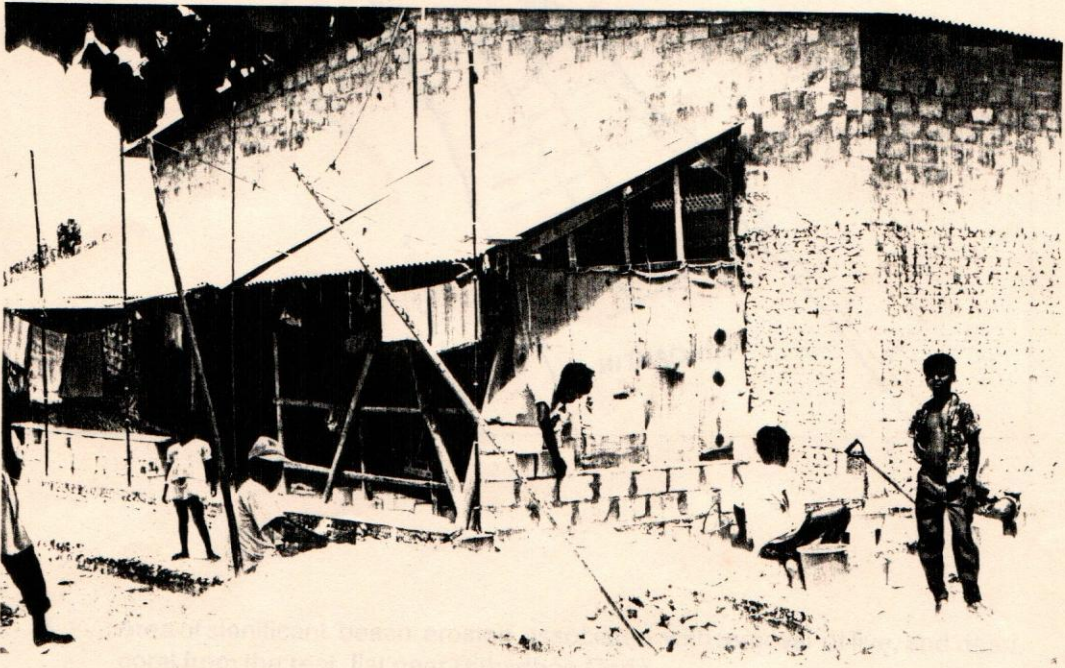
Plate 10 - Supplies of sand in atoll lagoons are large. The use of sand for sand/cement blocks from designated areas in these lagoons should be encouraged

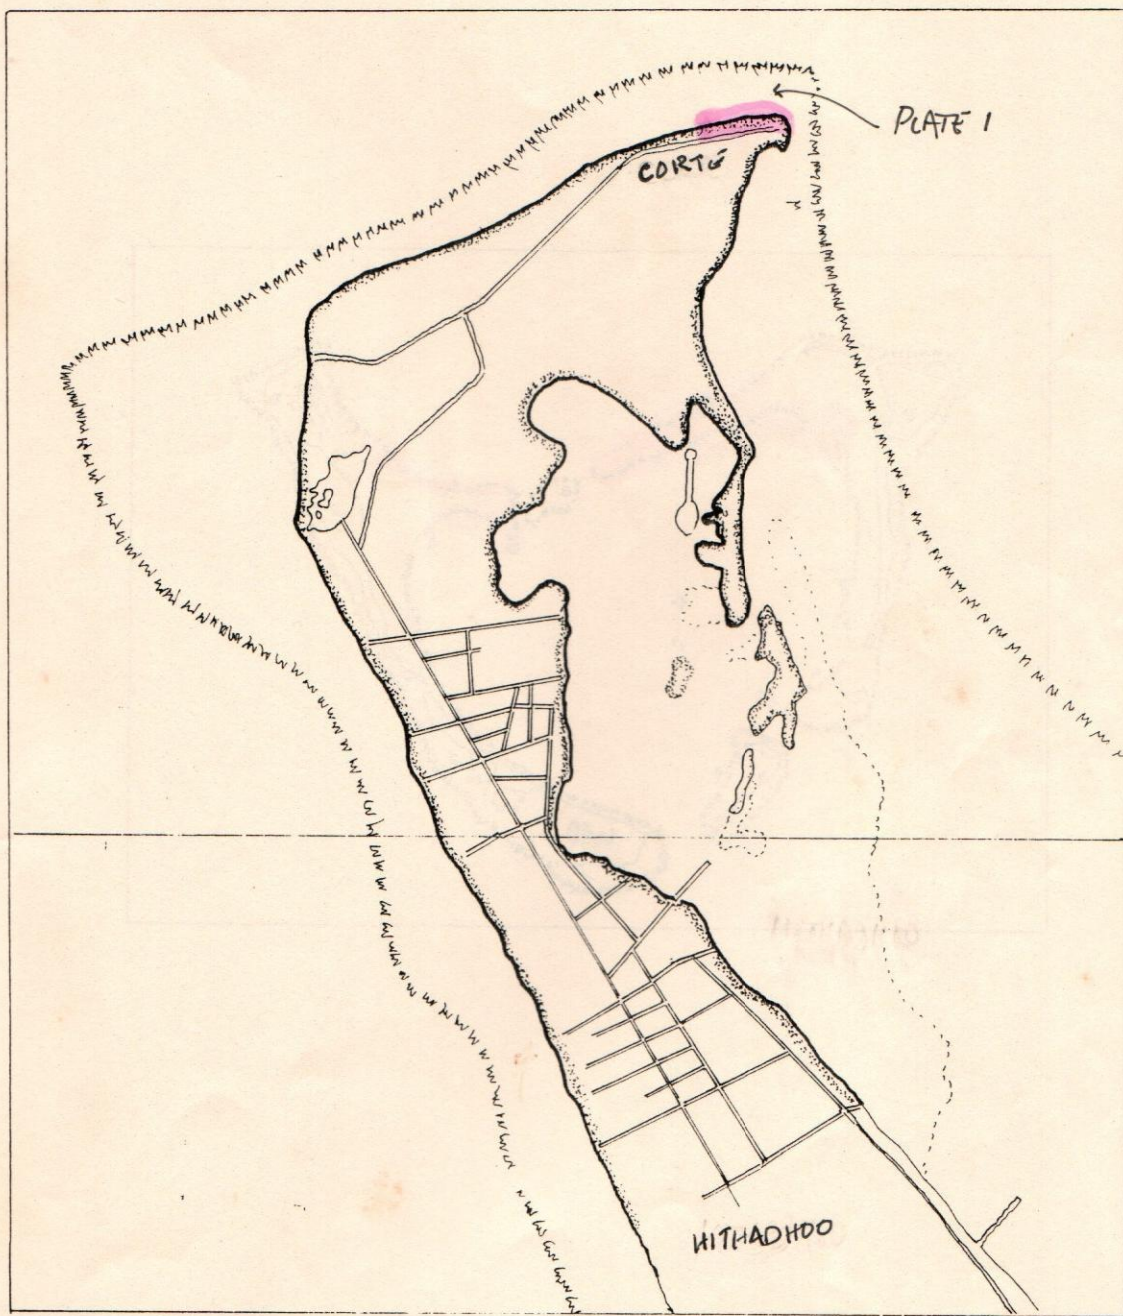
Fig. 1 - Area of significant beach erosion associated with removal of live, and dead, coral from the reef flat near Hithadhoo Corte.

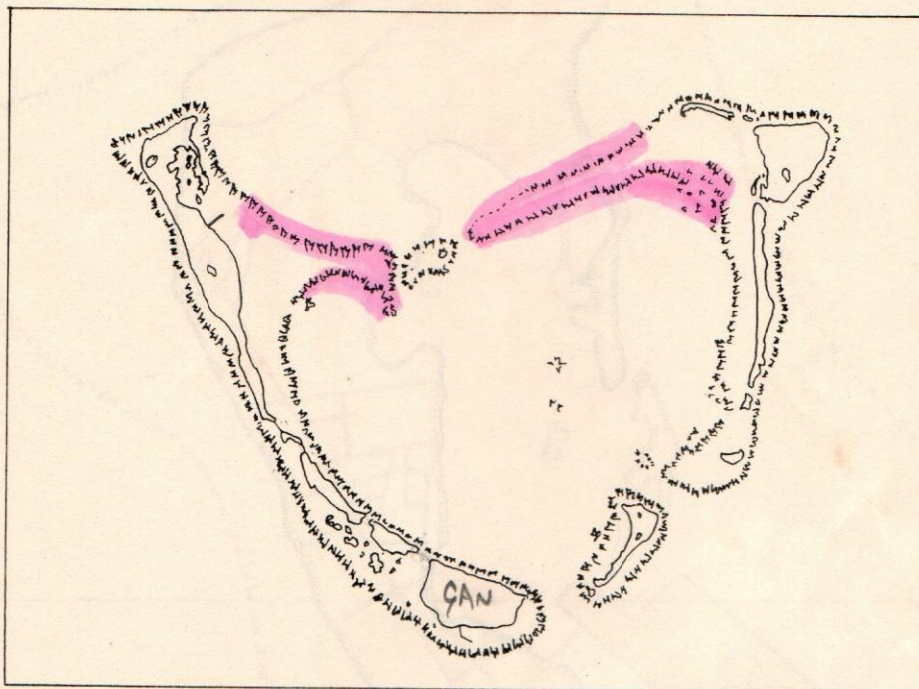
Fig. 2 - Areas to which coral mining should be restricted (at least 1km from any beach).

- 3 Population increase and the expanding economy are likely to maintain demand for coral if alternatives are not used.
- 4 For these reasons, and until alternative building materials are readily available coral mining in Addu should be restricted to the areas identified on the accompanying map (fig. 2).

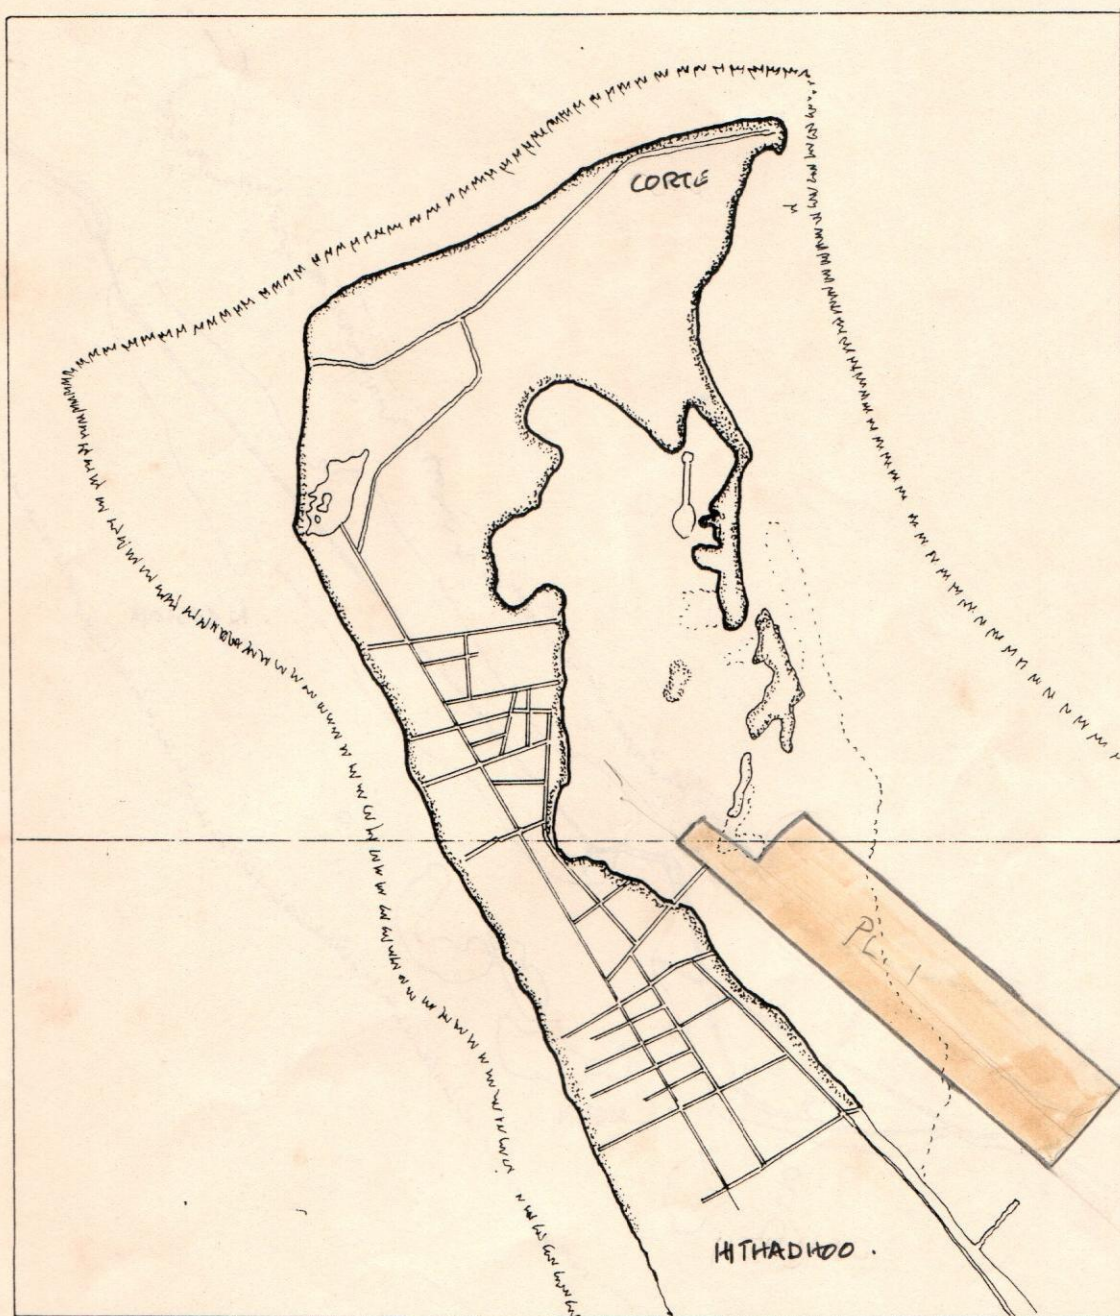
Fig. 3 - Area proposed for sand mining in the lagoon off, and to the southeast of, Hithadhoo jetty.

There are substantial sublittoral sand deposits that can meet projected demands for sand if they are exploited. The location of deposits is shown in the accompanying map (fig.3 southeast from Hithadhoo Jetty, fig.4 off the Gan-Fedu and Fedu-Maradu Causeways, fig.5 off Meedhoo Jetty). Substantial deposits of aggregate exist behind beach lines at Corte, Hithadhoo (fig.7) and could be exploited in the short (10 year term). Imported aggregate might be needed after this time.

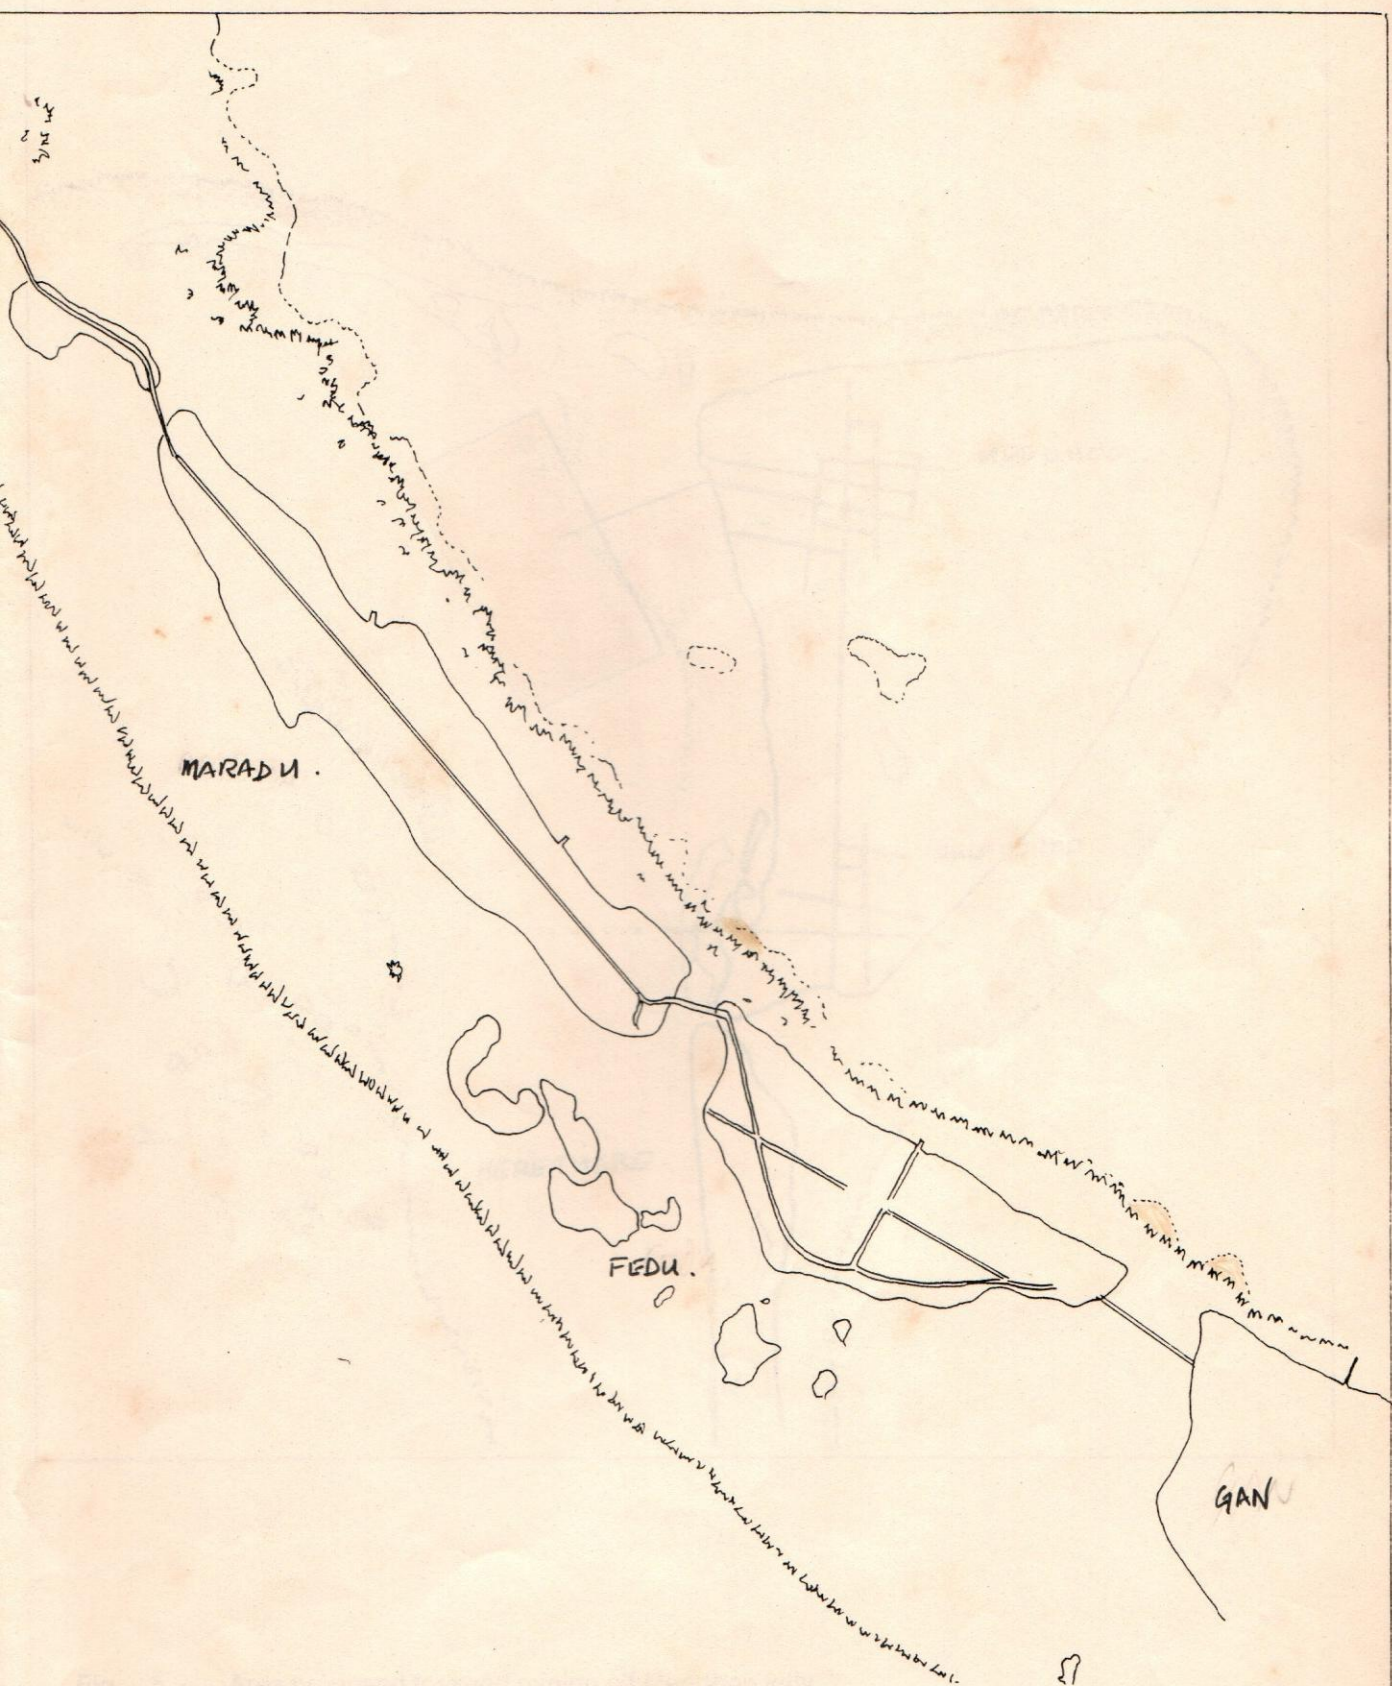
g. 4 - Area proposed for sand mining off the Gan-Fedu, and Fedu-Maradu, causeways.

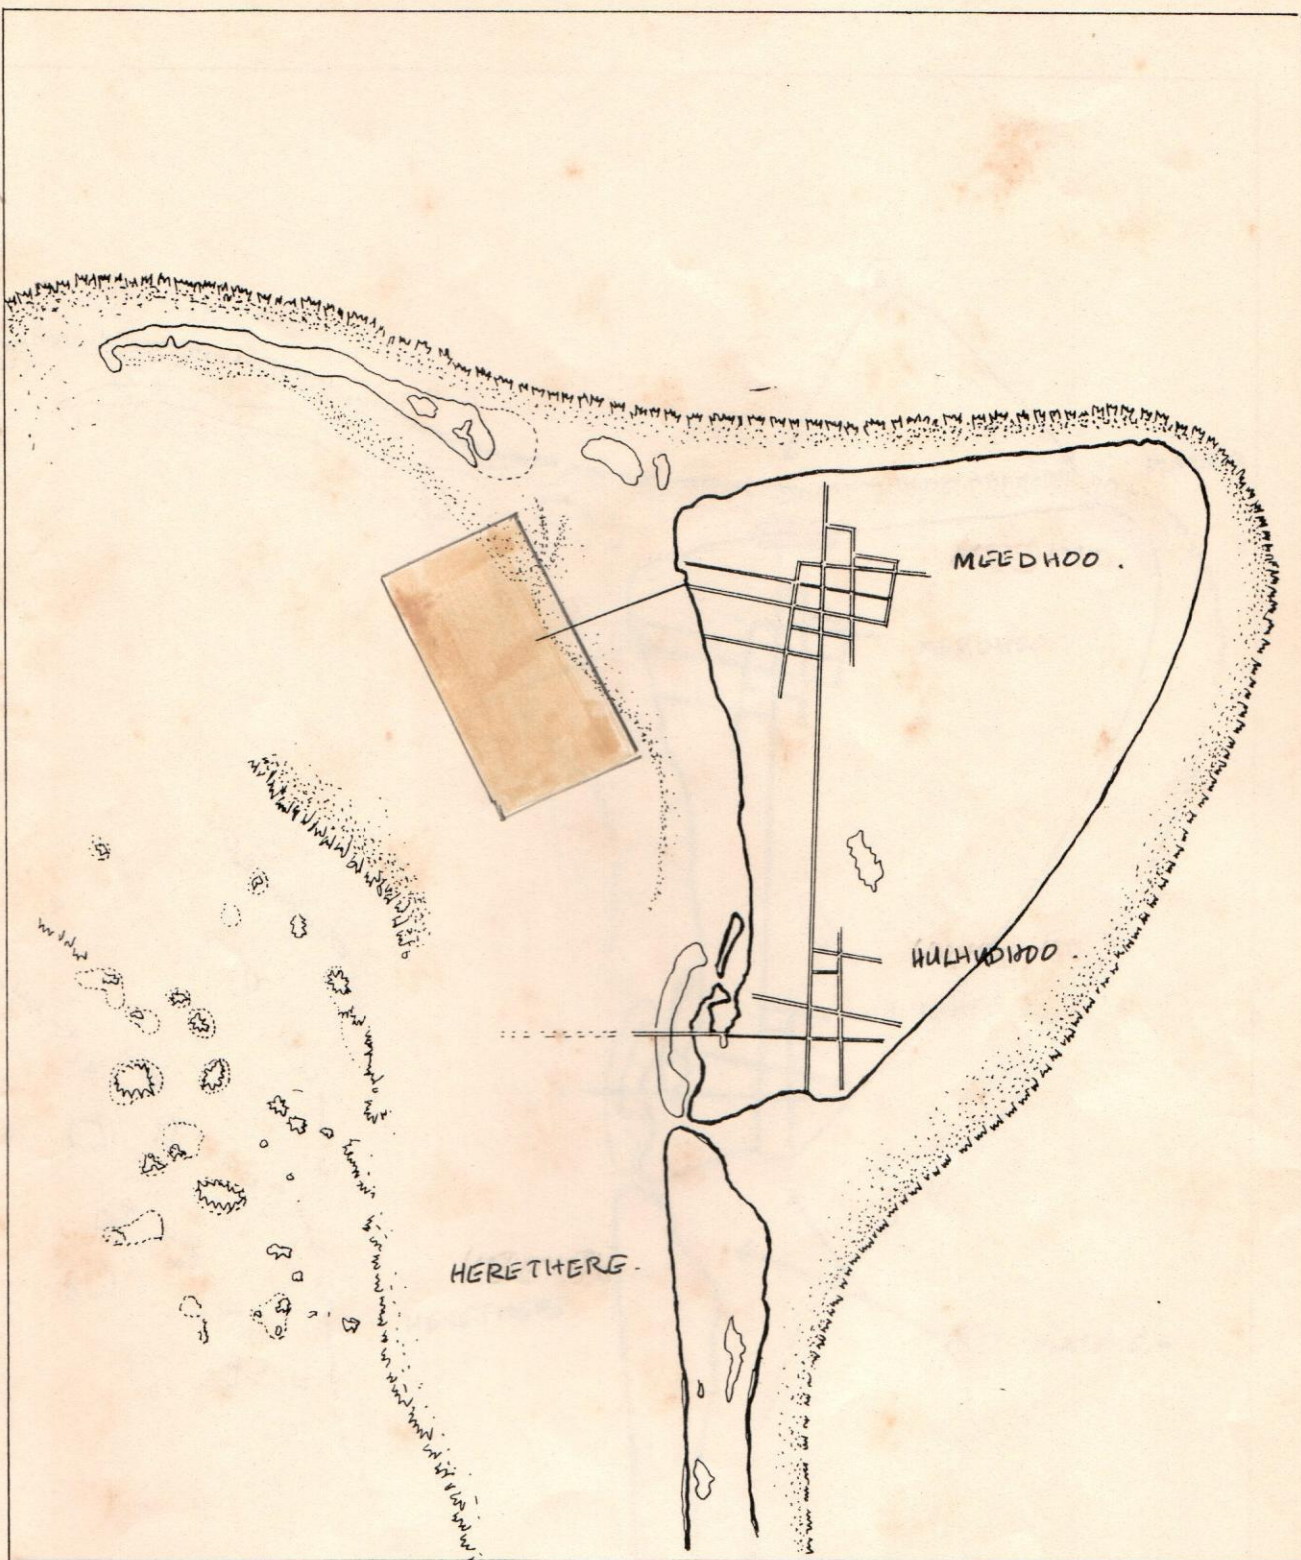
Fig. 5 - Area proposed for sand mining off Meedhoo jetty.

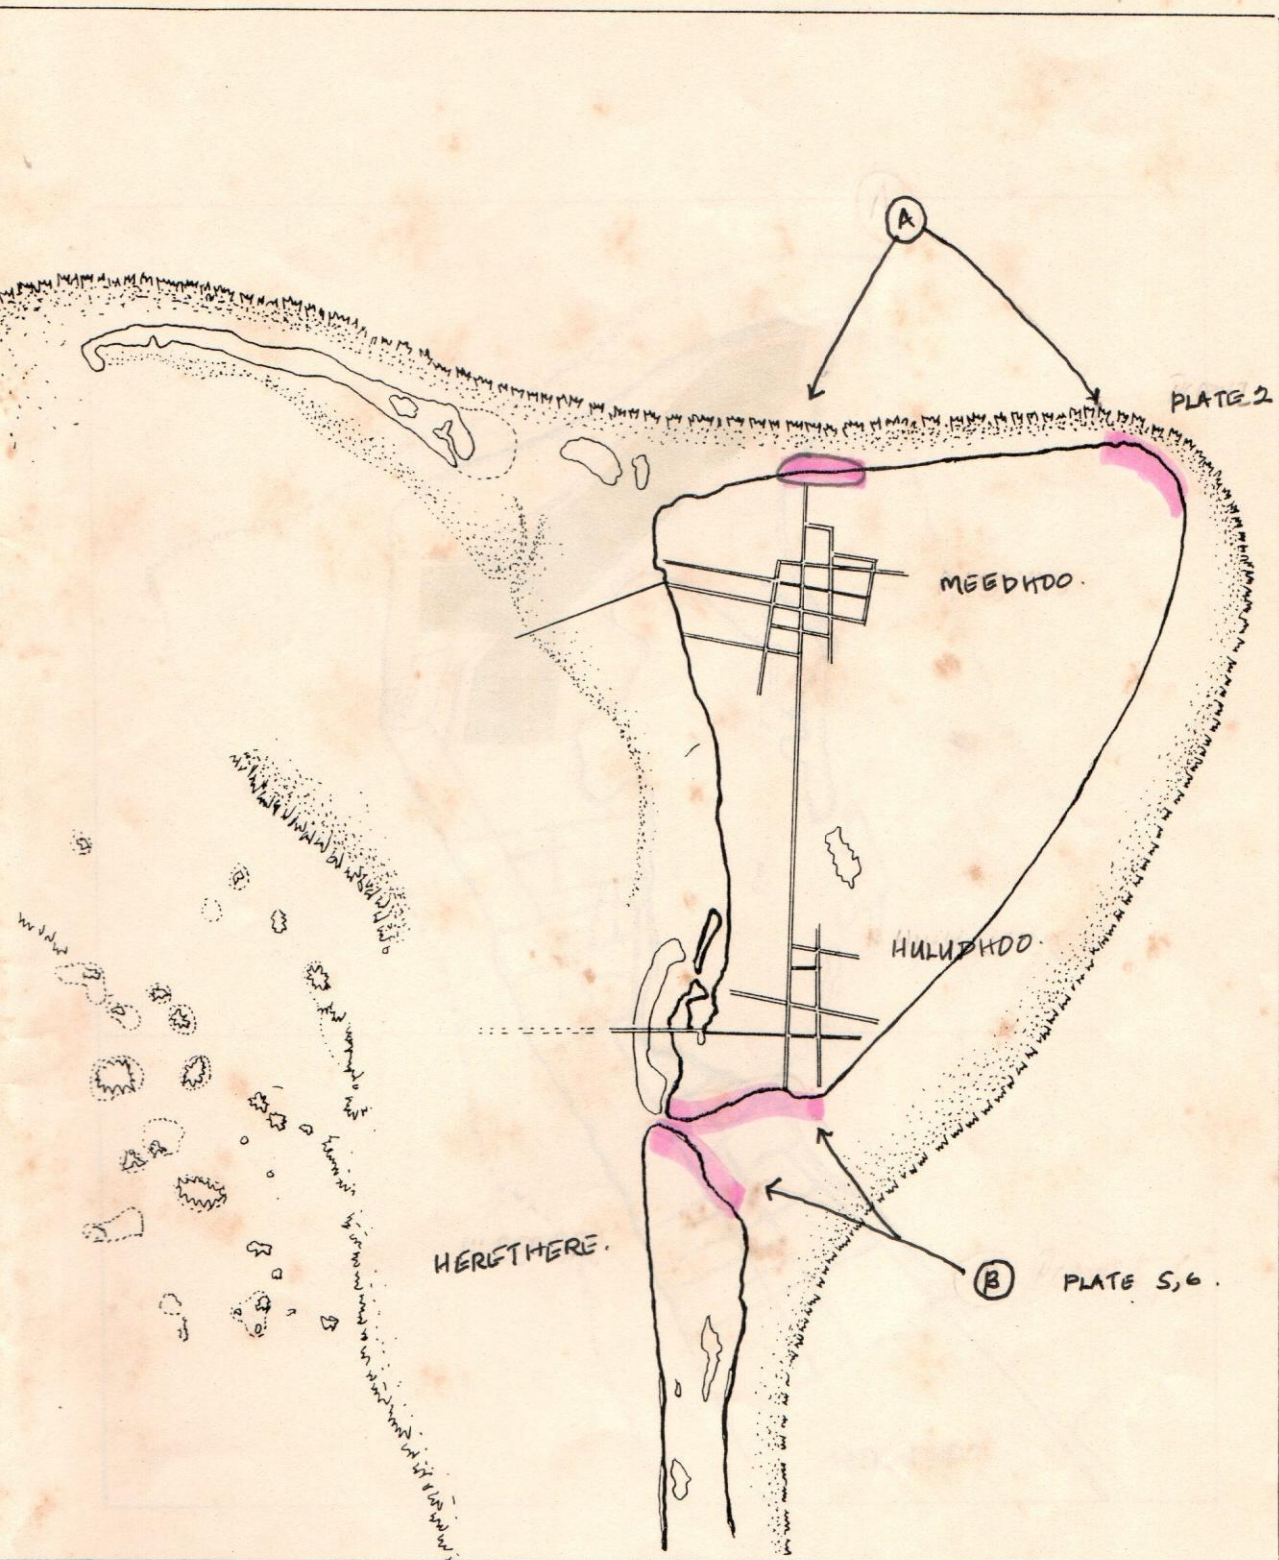
Fig. 6 - Areas of significant beach erosion associated with aggregate mining and storm damage (A) and from opening-up of a channel between Hulludhoo and Heretthere (B).

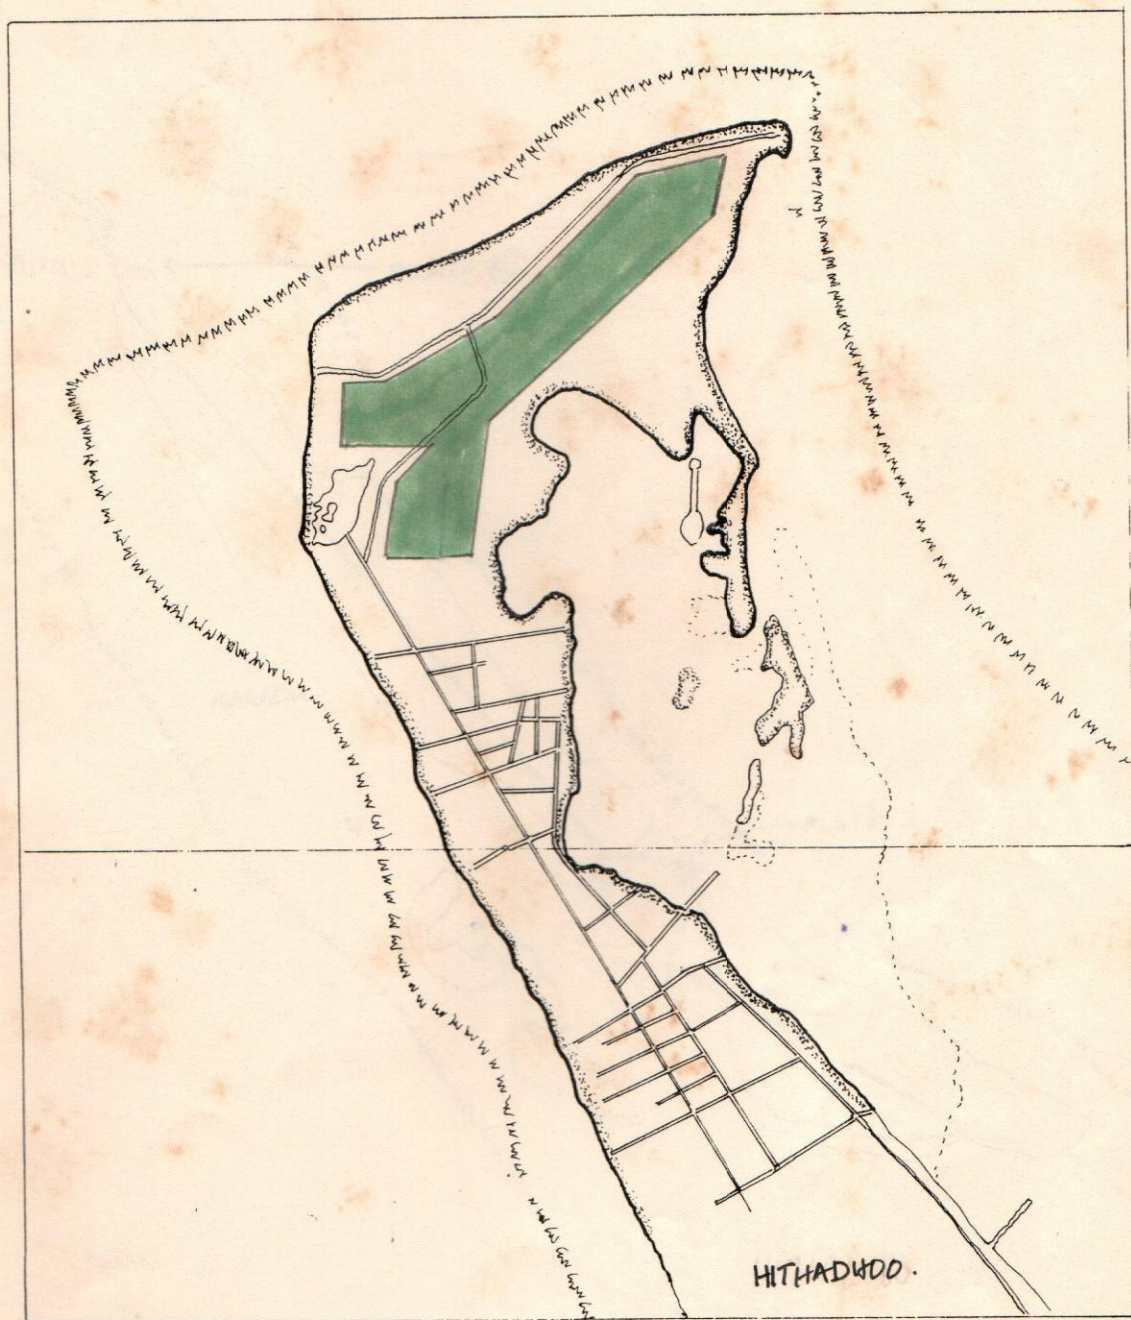
Fig. 7 - Area of aggregate deposits approved for mining.

- 1 Aggregate mining from beaches is a localised cause of beach erosion on the west shore of Hithadhoo (plate 1) and parts of the east shore of Meedhoo (fig. 6, plate 2). Beach erosion will become increasingly significant if beach mining is not restricted.
- 2 For this reason aggregate mining in Addu should be restricted to the area 20m behind the beach lines on Hithadhoo between Corte and Hithadhoo village (fig. 7).

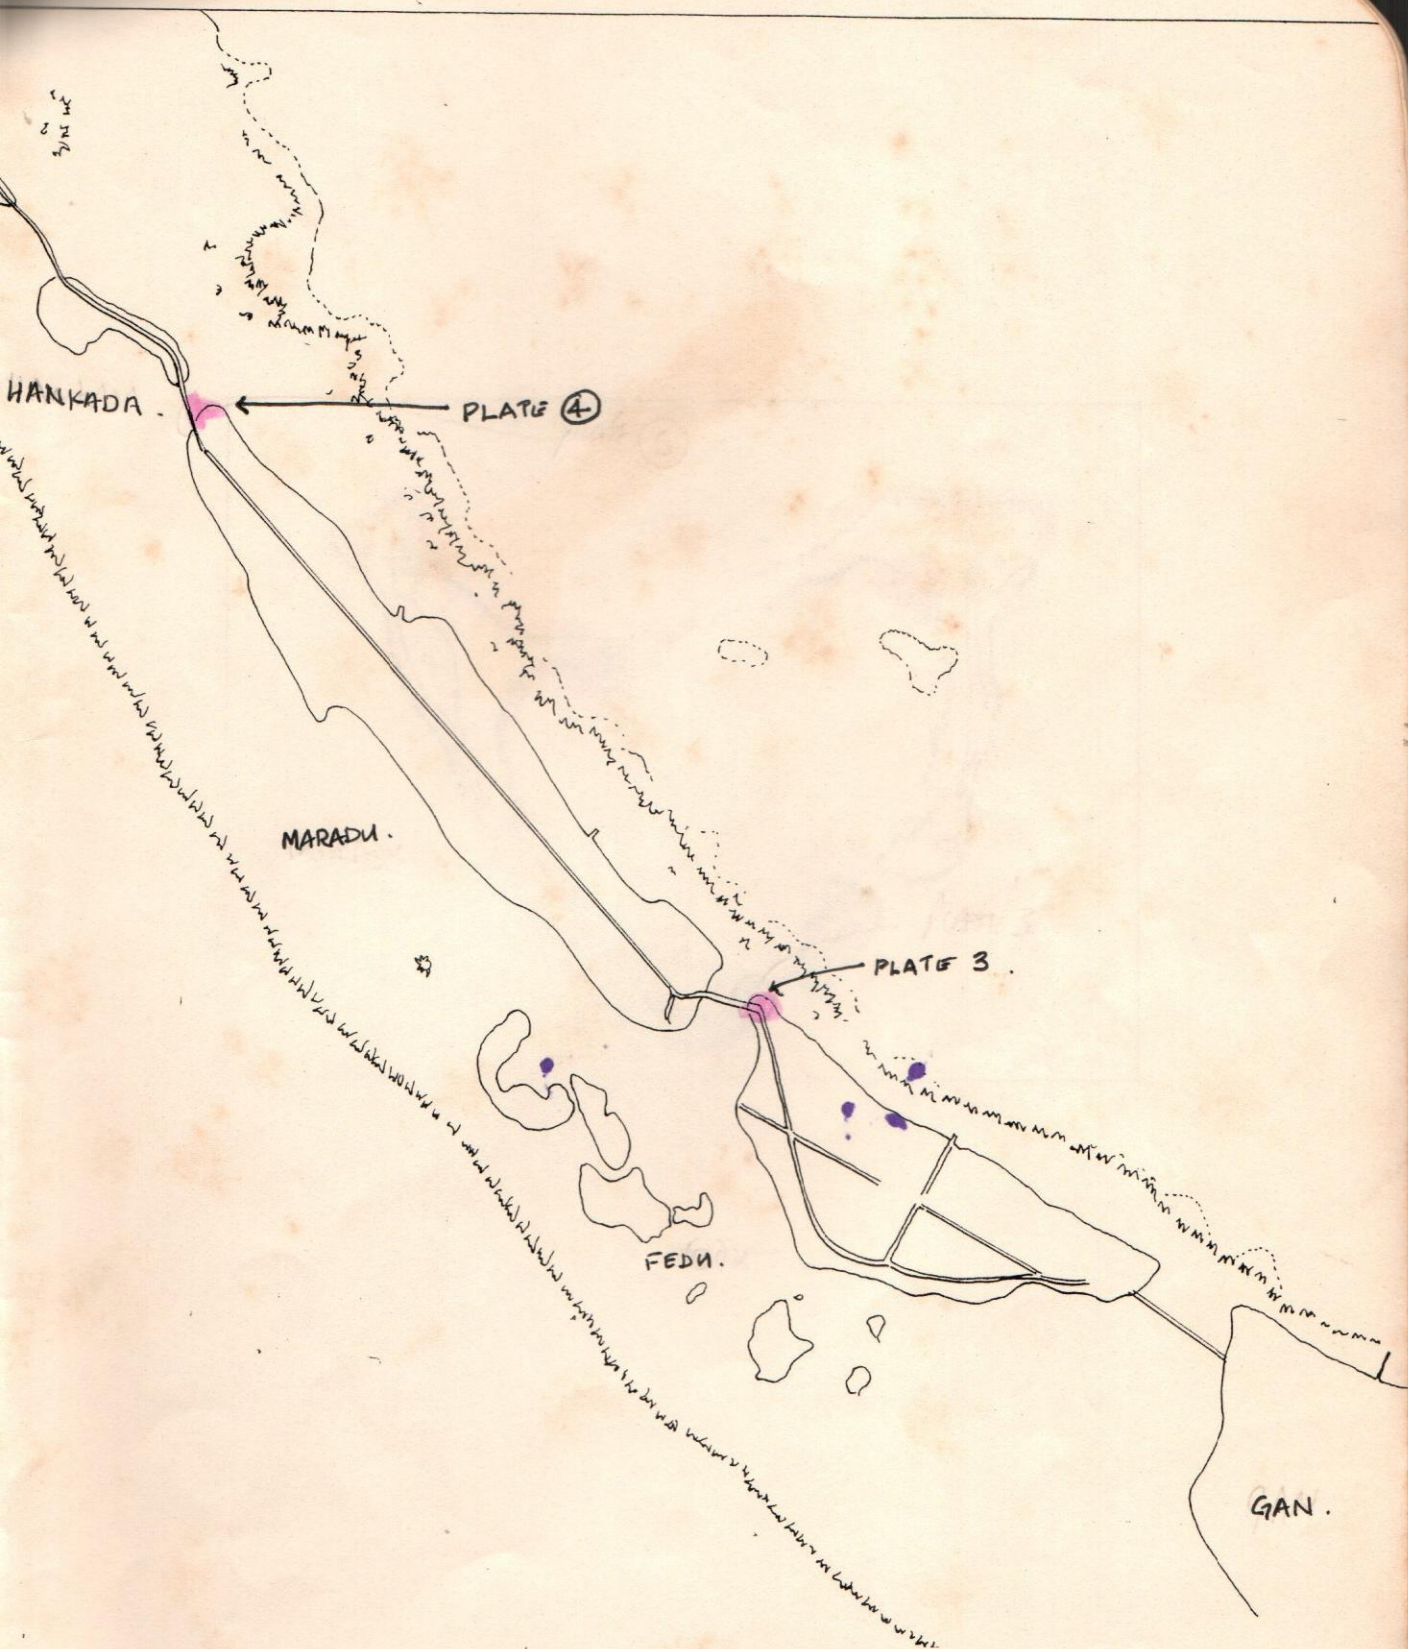
g. 8 - Areas of significant beach erosion associated with solid causeway construction. Some beach erosion is evident along much of the shoreline of these islands.

- 1 The most serious reason for beach erosion on Fedu, Maradu, Hankada, and the southeastern end of Hithadhoo is the presence of solid causeways (fig. 8, plate 3-4).

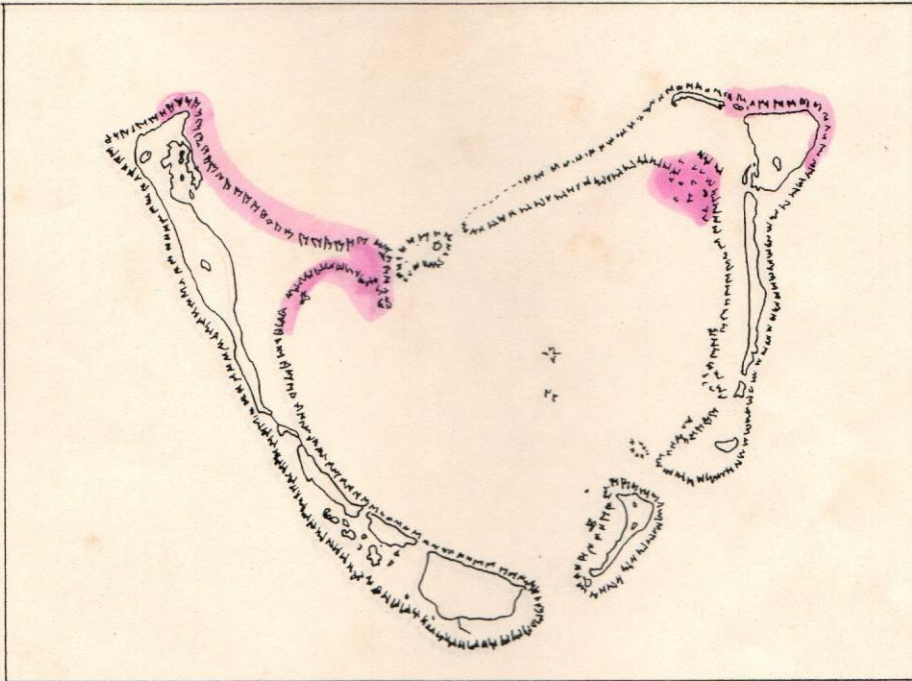
Areas where coral is mined are shown in figure 9 and include:-

- Inner reef extending eastwards from the northern half of Hithadhoo almost in front of Hithadhoo jetty.
- Outer reef flat and reef front of the same area.

Fig. 9 - Areas where coral is currently mined.

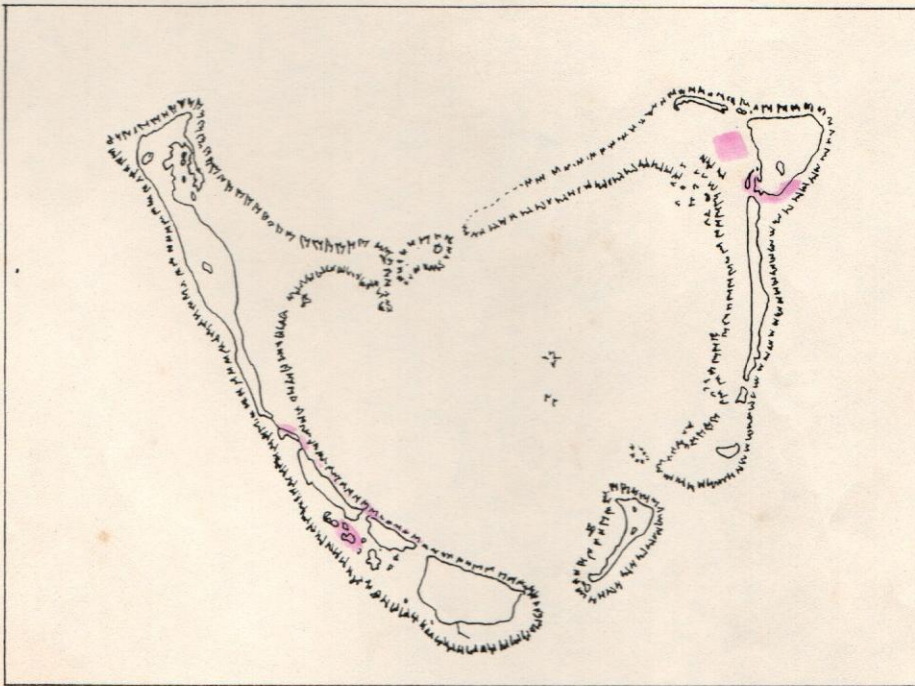
Areas where sand is collected are shown in figure 10 and include:-

- Lagoonside beaches of inhabited islands.

Fig. 10 - Areas where sand is currently mined.
