**ADDU CORAL MINING / BEACH EROSION
STUDY**

30 JANUARY - 1 FEBRUARY 1990

Prepared By
MARINE RESEARCH SECTION
MINISTRY OF FISHERIES AND AGRICULTURE
REPUBLIC OF MALDIVES

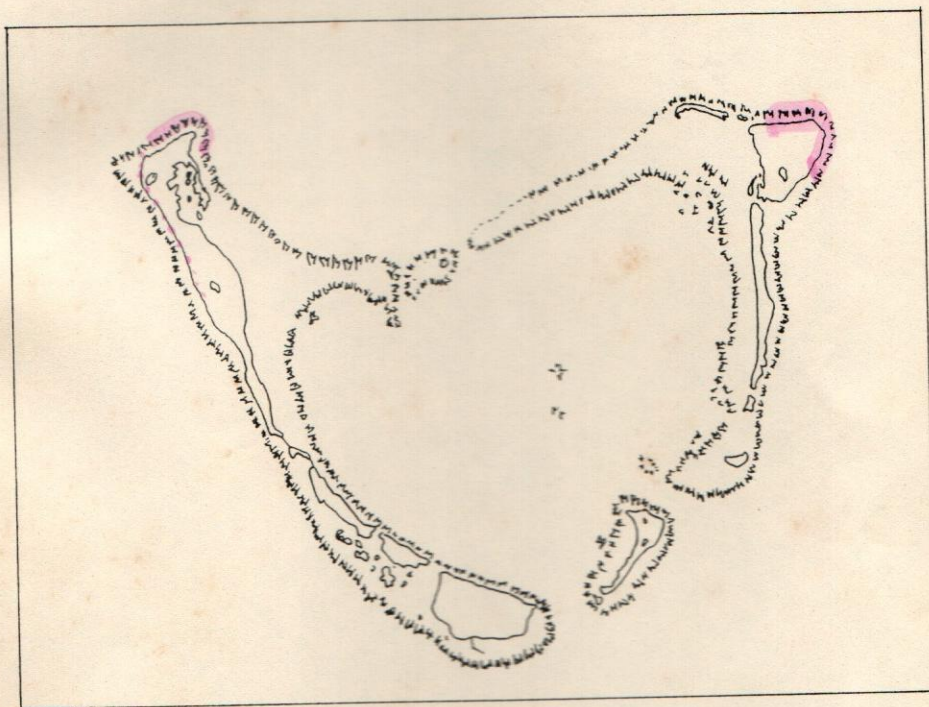
Areas where aggregate is collected are shown in figure 11 and include:-

- Corte and Fenmuli.

Fig. 11 - Areas where aggregate is collected.
